MARINE STRUCTURES
THEIR DETERIORATION AND PRESERVATION

REPORT

COMMITTEE ON MARINE PILING INVESTIGATIONS
of the DIVISION OF ENGINEERING AND INDUSTRIAL
RESEARCH *of the* NATIONAL RESEARCH COUNCIL

WILLIAM G. ATWOOD and A. A. JOHNSON

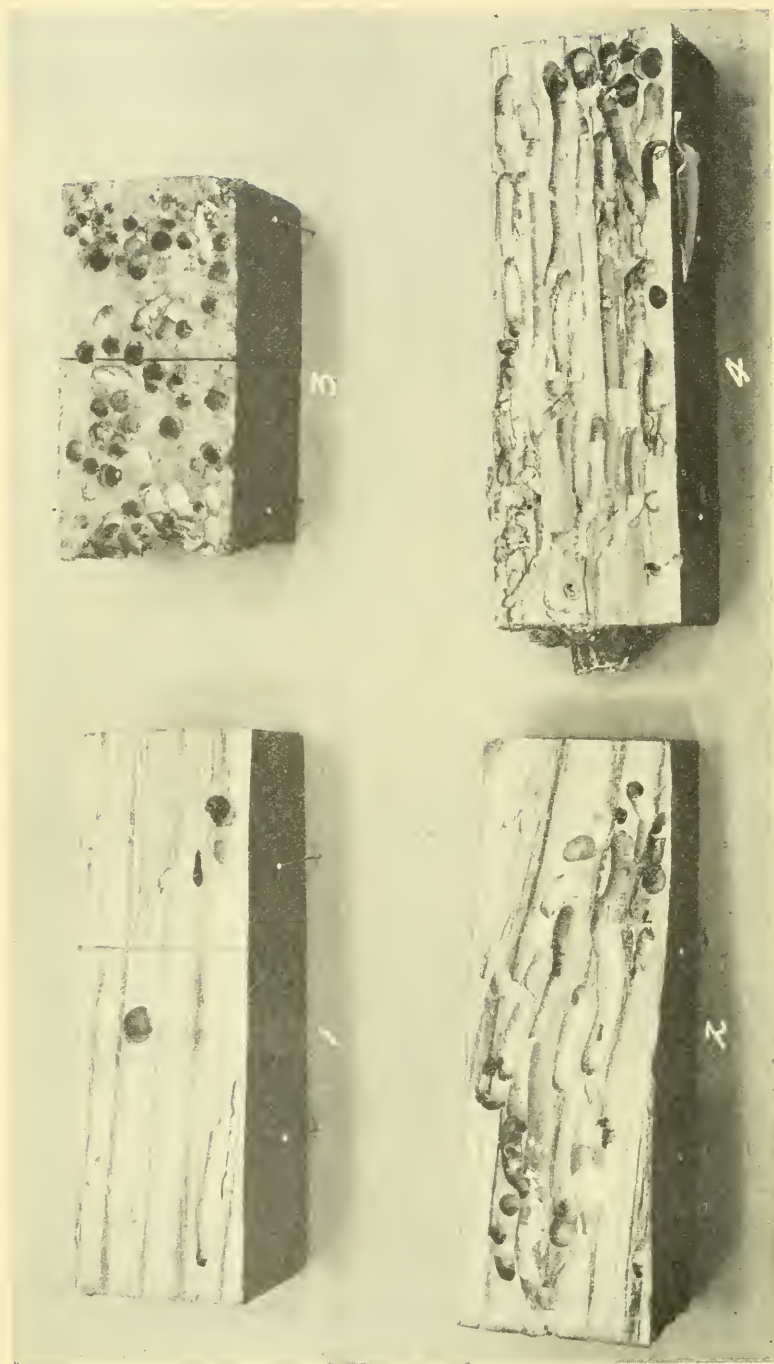
FIG. 4.—SECTIONS OF BLOCKS FROM NEW YORK, NEW HAVEN & HARTFORD R.R. TEST BOARDS INSTALLED JUNE 1, 1922.

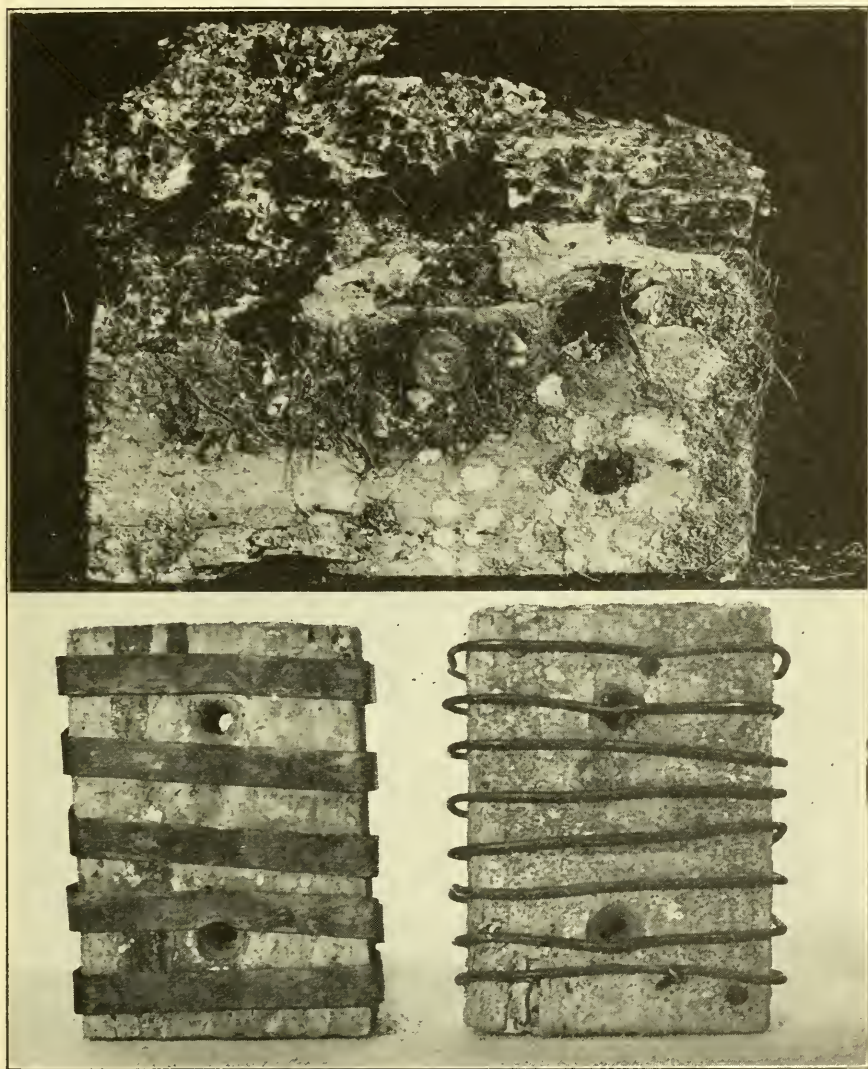
When these blocks were removed after this three months' period it was found that the copper had slowed up the destruction very appreciably (Fig. 6), and that the strips were more effective than the wire. The animals in both the bound blocks appeared to be dead, while those in the unbound block were many of them alive. On account of this encouraging result, eight test boards were prepared by the U. S. District Engineer at Charleston, S. C., and immersed at Castle Pinckney, where the attack was known to be heavy. These blocks were bound with $\frac{1}{2}$ -in. copper strips and with wire spaced from $\frac{1}{2}$ in. to $2\frac{1}{4}$ in., varying by $\frac{1}{4}$ in., with every third block unprotected as a control. Seven sets of blocks were mounted on galvanized bars and the eighth on a palmetto pole. The blocks from these boards were removed periodically as in the case of the standard boards.

FIG. 6—TESTS OF COPPER WIRE AND BANDS, CHARLESTON, S. C.
BOARD SUBMERGED SEPTEMBER 6, 1922

It would therefore appear that the copper strips 1 in. apart, while they caused a much less intense attack, did not give ultimate protection.

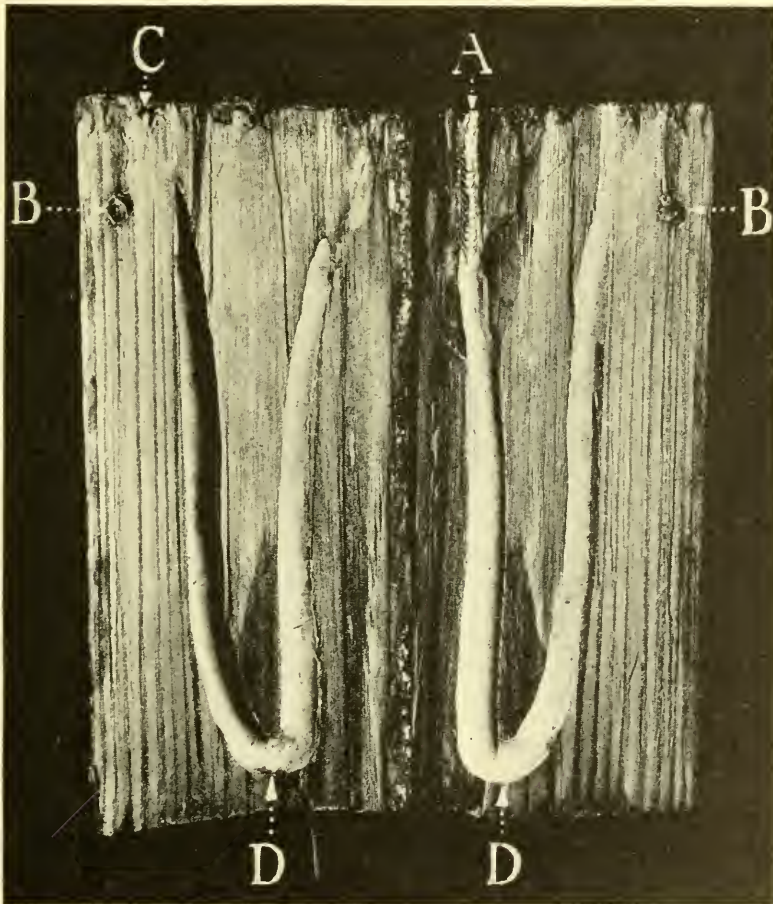
FIG. 16—*Bankia setacea* 12 INCHES LONG IN TEST BLOCK FROM COOS BAY, ORE. BLOCK PLACED JUNE, 1921; REMOVED OCTOBER, 1922.

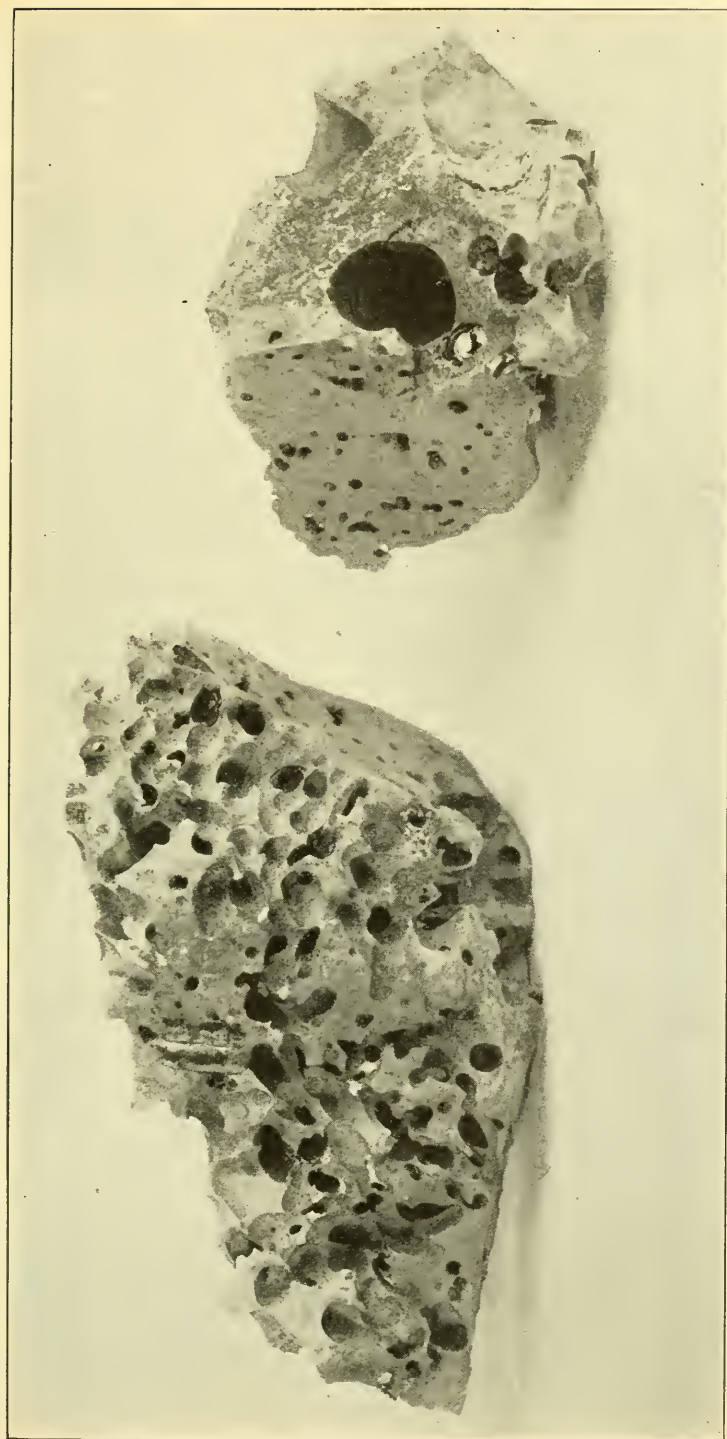
FIG. 17.—SPECIMENS OF STONE FROM RIP-RAF AROUND WEST RIGOLETS LIGHTHOUSE, LA., PERFORATED BY BORERS — *Lithophaga*
(*Dulerus*) *Bisculata* ORBIGNY AND *Gastrochaena* *Ovata* SOWERBY

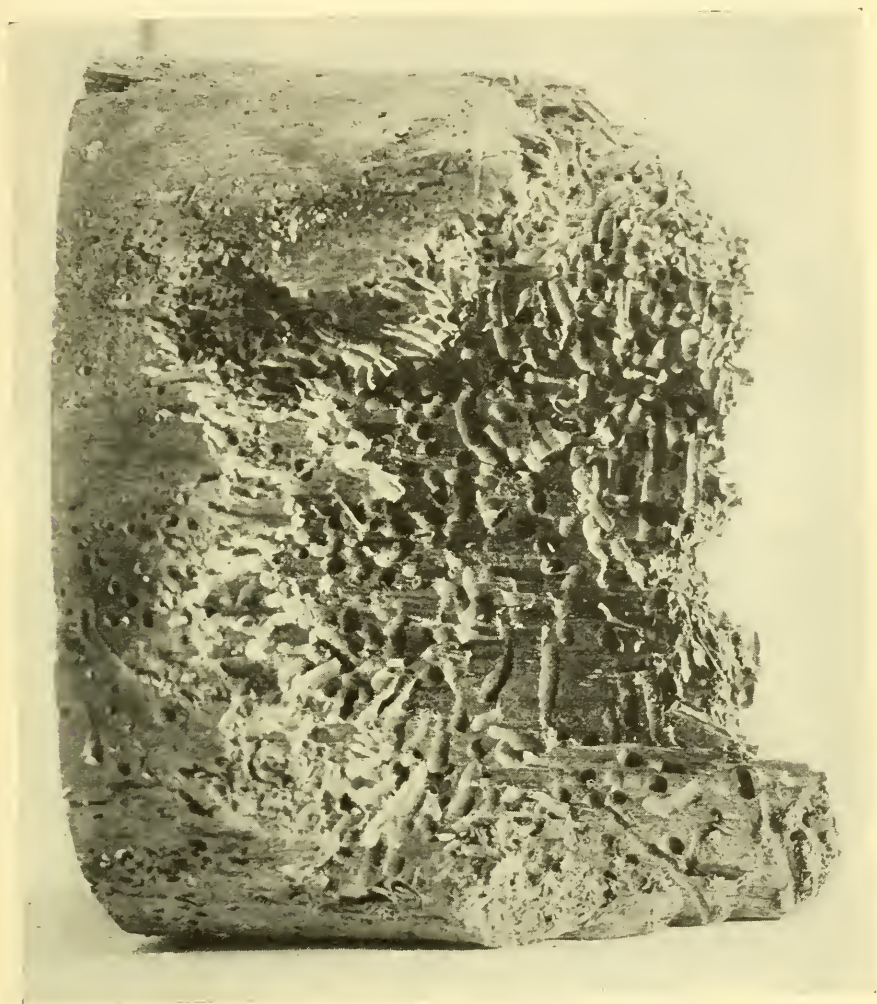
FIG. 19—SECTION OF JUCARO PILE FROM DOLPHIN OF TEXAS OIL COMPANY,
MATANZAS, CUBA

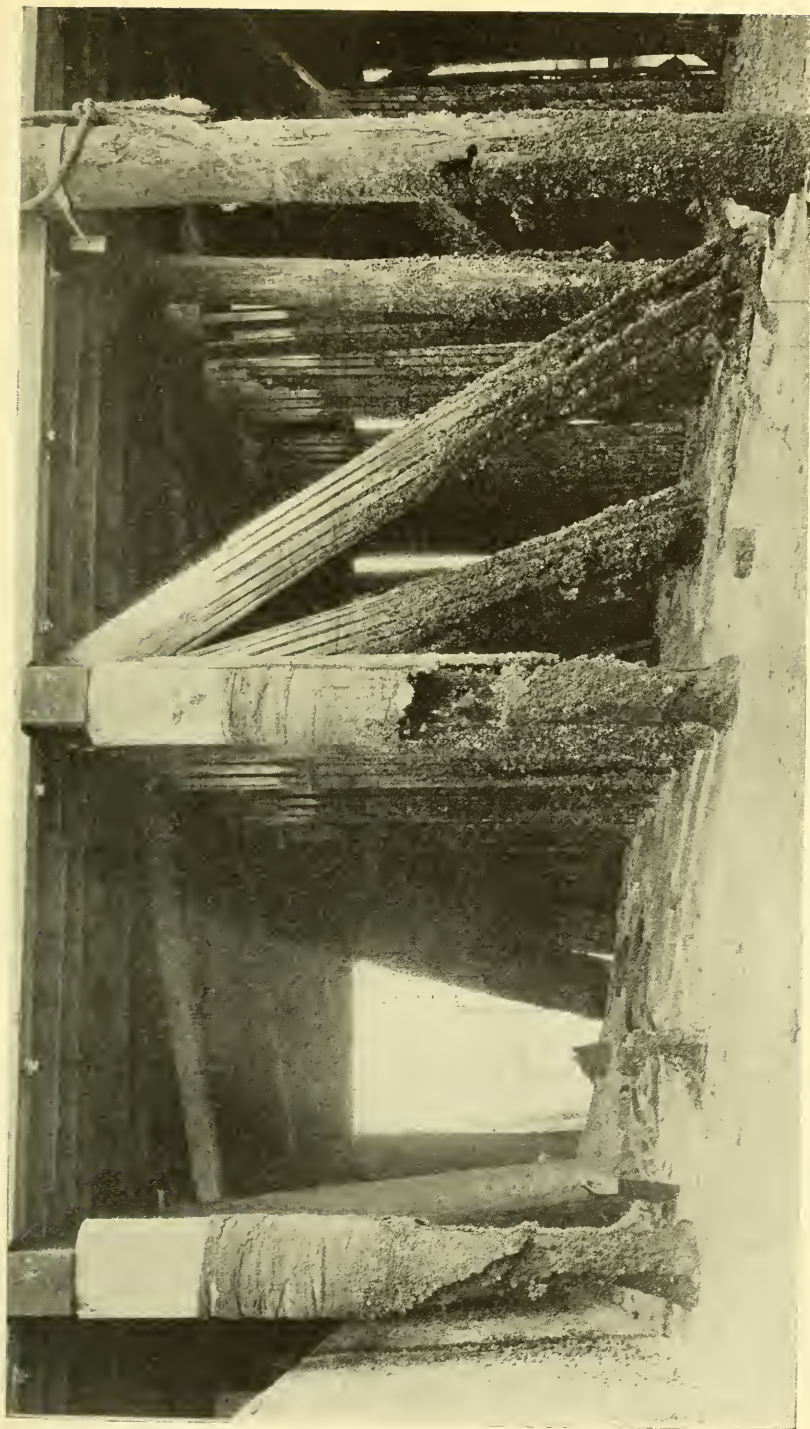
FIG. 21—PERFECTION PILES DRIVEN IN 1903 IN COAL WHARF AT THE PUGET SOUND NAVY YARD.

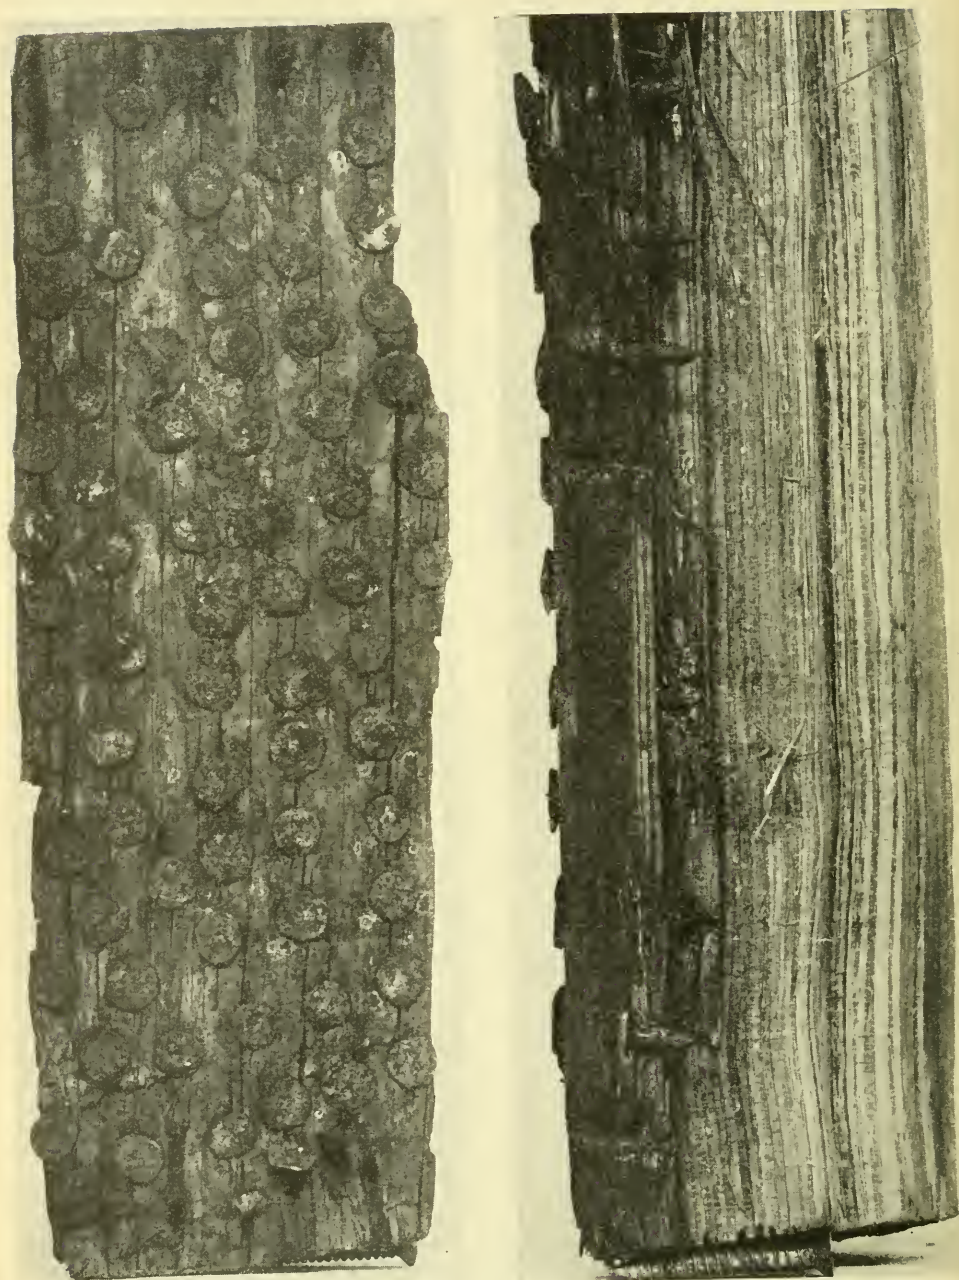
FIG. 22—SECTIONS OF PILE FROM WHARF OF THE CHARLESTON DRY DOCK
AND MACHINE CO., CHARLESTON, S. C., WITH 4 YEARS' SERVICE

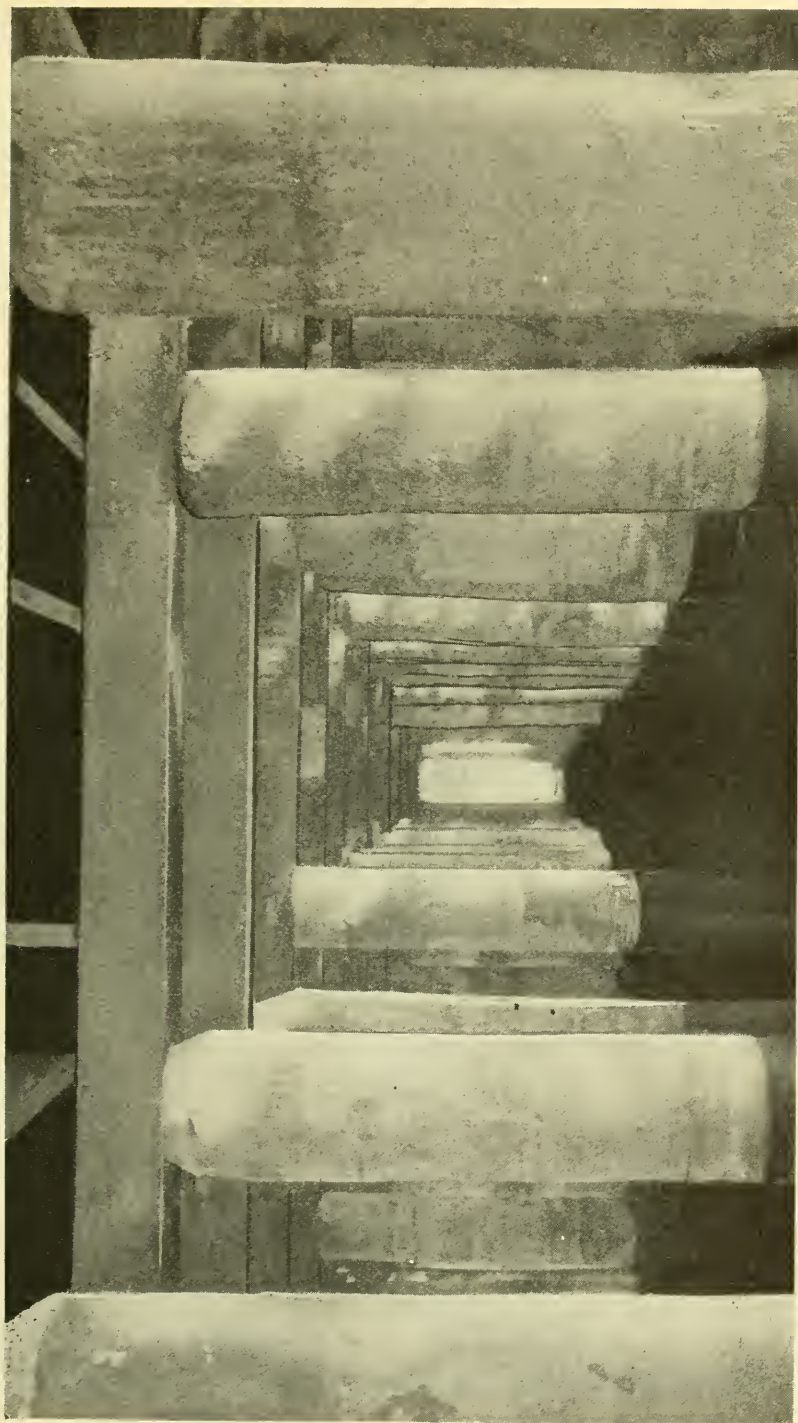
FIG. 23—GUNITE CASINGS ON SHELL OIL CO.'S WHARF, MARTINEZ, CAL.

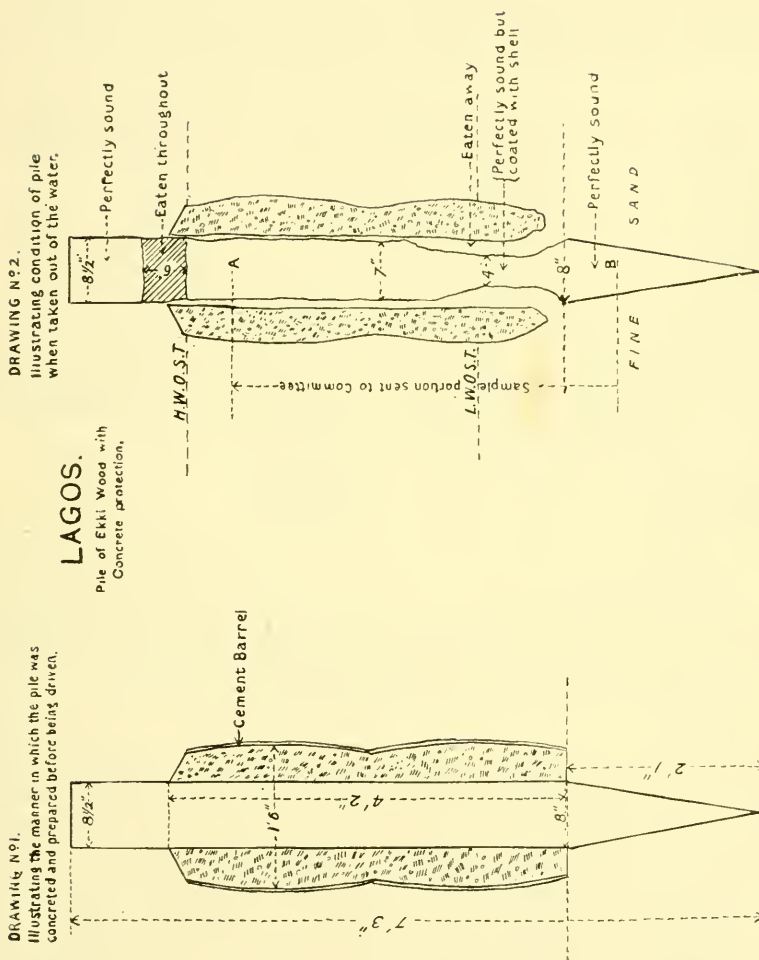
FIG. 25.—SKETCH SHOWING RESULT OF BUILDING CASINGS TOO SHORT.
(REPRODUCED FROM 1ST REPORT, INST. OF CIVIL ENGINEERS)

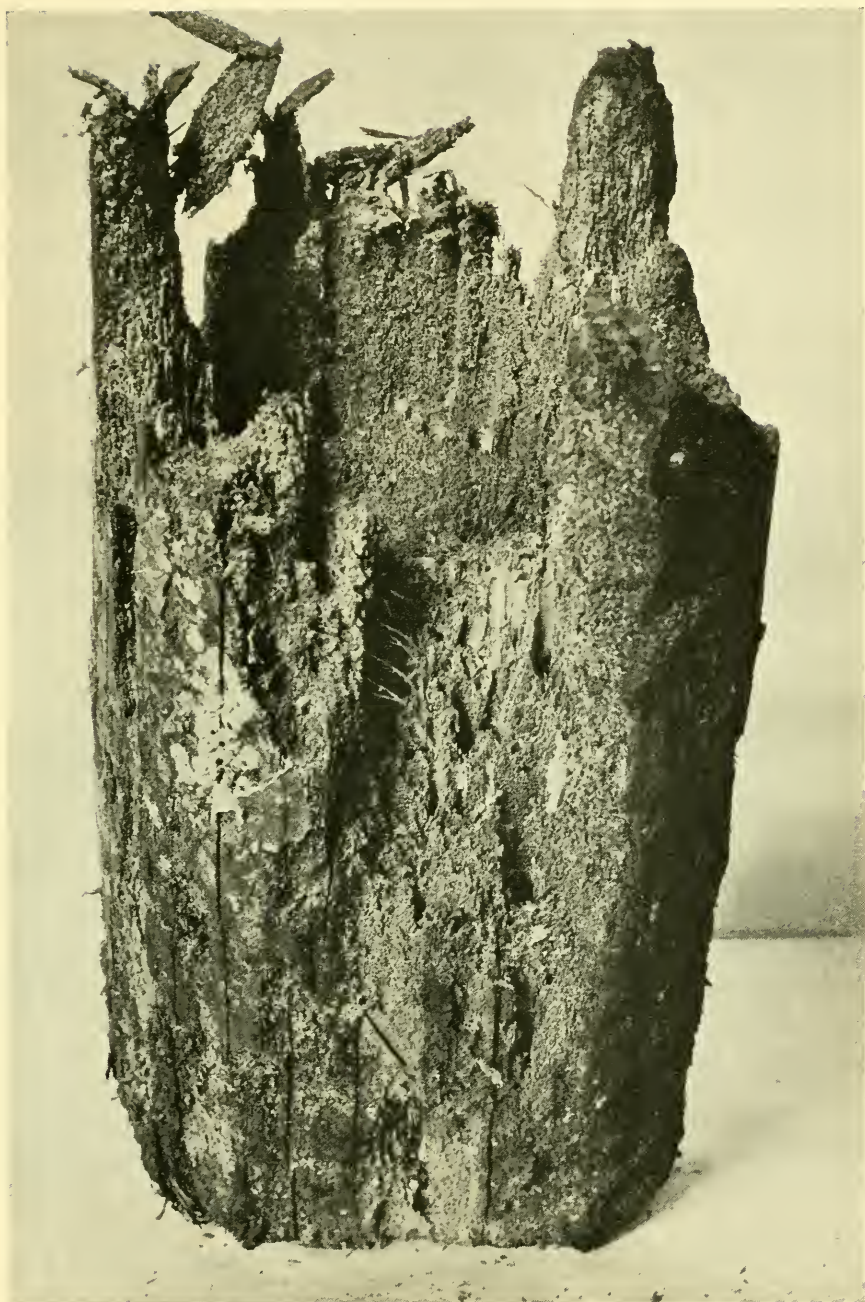
FIG. 27—SECTION FROM CREOSOTED PINE PILE—16 LB. TREATMENT—U. S. NAVAL STATION, ST. THOMAS, V. I.

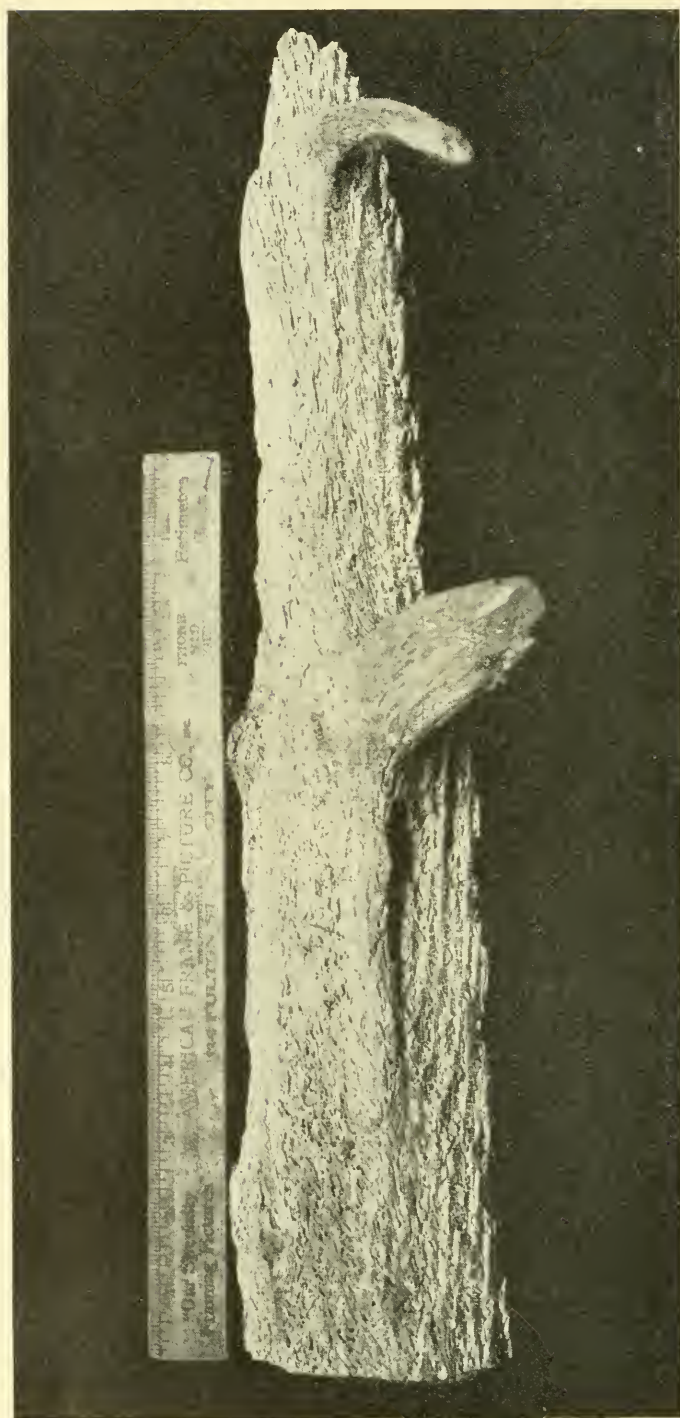
FIG. 42—SECTION OF PILE DRIVEN IN GRAND TRUNK RY. PIER AT PORTLAND, MAINE, SHOWING *Limnoria* ATTACK. PIER DESTROYED BY BORERS

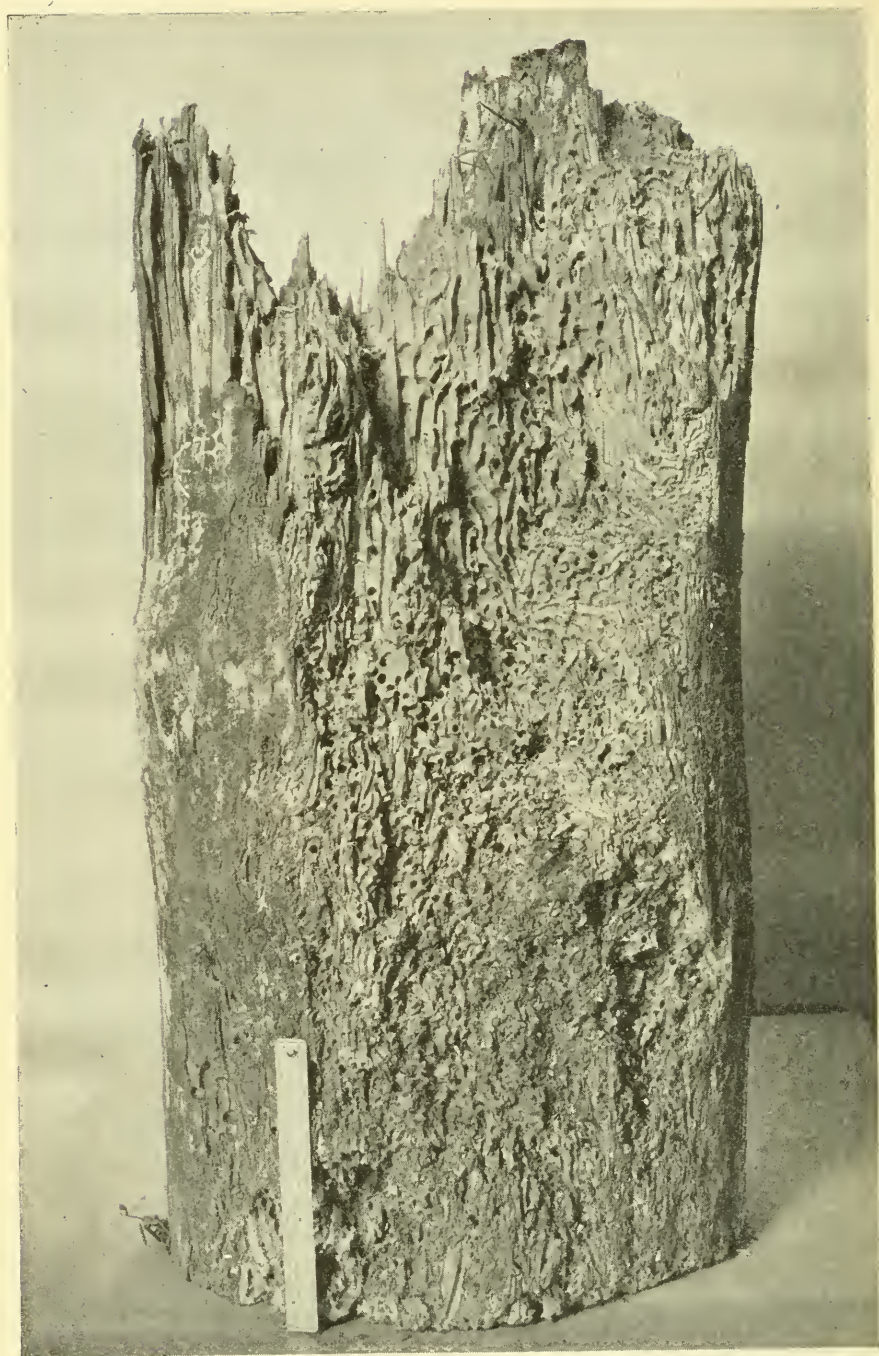
FIG. 64—UNTREATED PINE PILE, U. S. N. SUBMARINE BASE, NEW LONDON, CONN.
Driven, 1918—Removed, 1923.

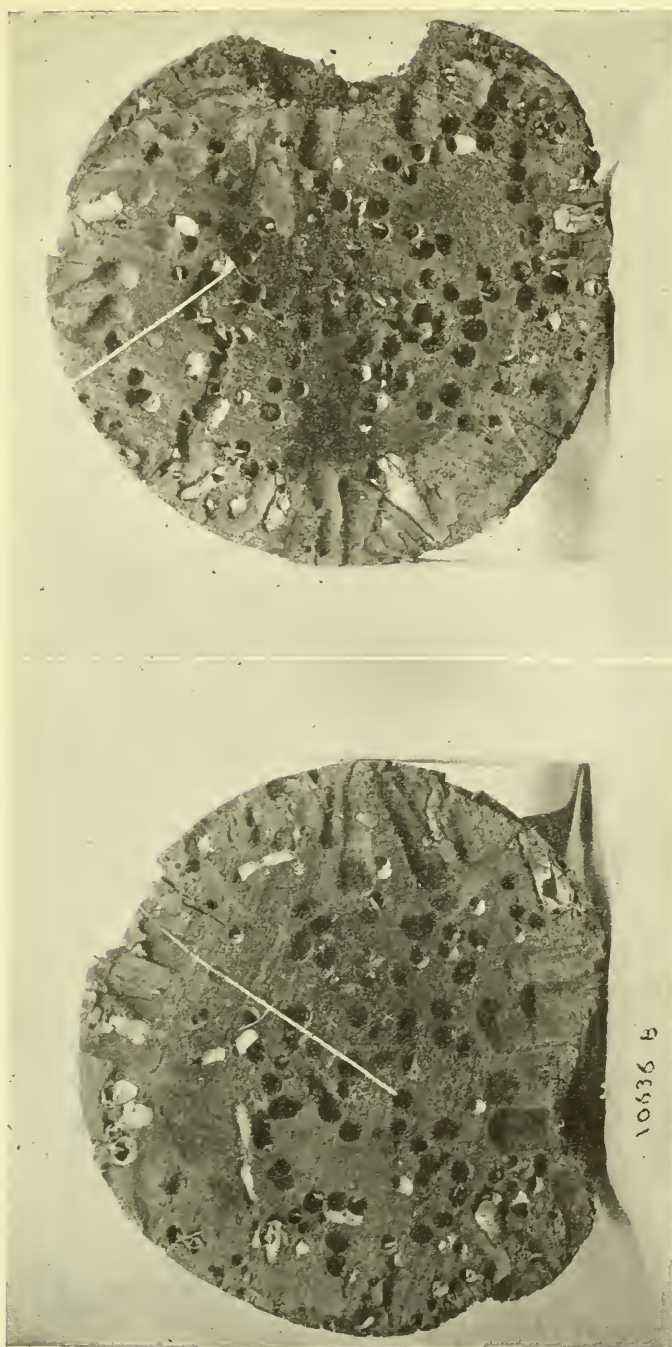
FIG. 114—SECTION OF UNPROTECTED PINE PILE WITH ONE YEAR'S SERVICE AT THE MOUTH OF THE MANATEE RIVER, TAMPA BAY.
ATTACKED BY *Bankia* AND *Martesia*.
